STEP 1: DETERMINATION OF SIGNIFICANCE STAFF REPORT

Site: 377 Washington Street

Case: HPC.DMO 2021.04

Proposal: Demolish all structures

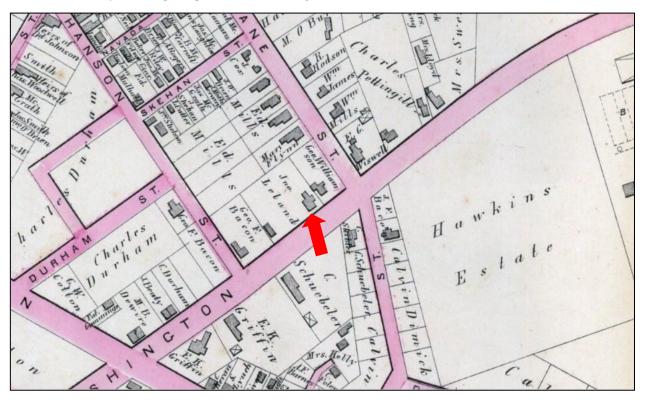
Below: Portion of 1874 Hopkins plate E. 377 Washington Street indicated.

The first time 377 Washington is noted on available maps is the 1874 Hopkins Plate E. At this time, the house is extant on a large tract of land owned by Jno. ("John") Leland. Though the 1874 map is the earliest map available, this doesn't mean that 377 Washington Street was built in 1874. It is quite possible that it was built as early as the 1860s as the Italianate style was popular and typical during that decade as well. There are two dwelling houses on Leland's tract of land at this time.

377 Washington Street shows a rectangular main massing, a right elevation jog and a smaller rear addition that is subservient to the main masing. The building is indicated on the 1874 map below:

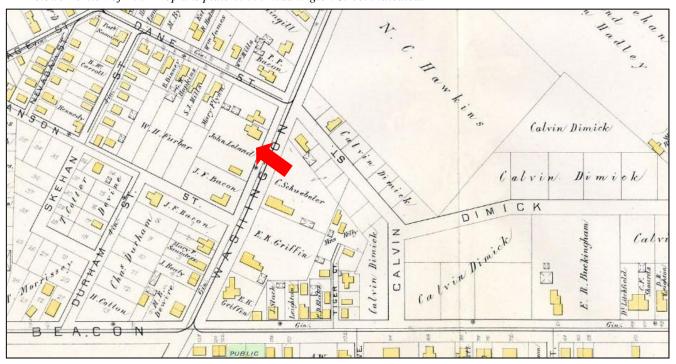
The 1884 Hopkins plate 8 shows that John Leland remains the owner of this same tract of land. Neither of the forms representing the residential structures show any addition or removal of building components.

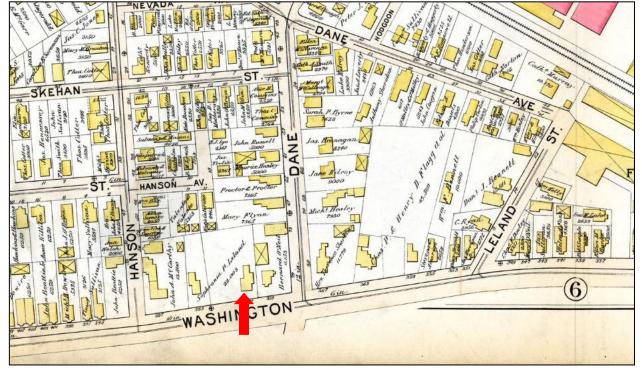
Below: Portion of 1895 Bromley plate 5. 377 Washington Street indicated.

The next available historic map, the 1895 Bromley plate 5 shows that John Leland's wife, Sophronia Leland, is now noted as the property owner. Ownership was likely transferred to her upon the death of John. By 1895, the original large tract of land has been subdivided into two parcels, both owned by his widow. 377 Washington Street receives the larger of the two new parcels. The house at 377 Washington retains its original shape.
